Applications Engineering Note

Issue Date: 17 December 2014

FuseConnect® Splice-on Connectors Motor Issues

Fujikura Fusion Splicer 70-series and 19-series Motor Issues

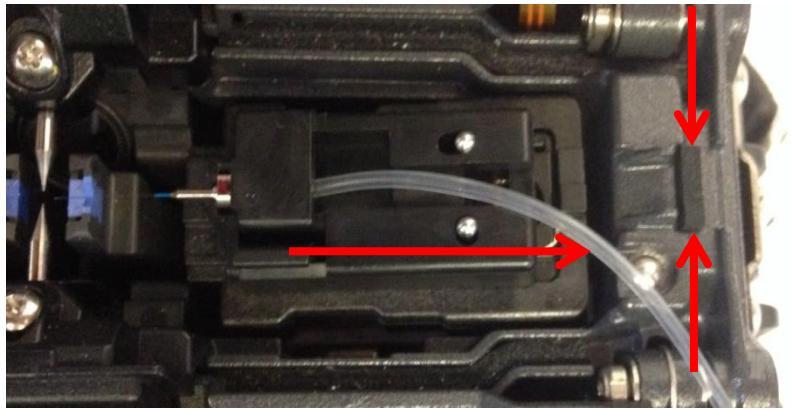
Figure 1: Incorrect placement of rubber transfer tubing.

METHOD A: Figure 1 shows the rubber transfer tubing on the FuseConnect pre-polished end not placed over the center of the clamshell. This may prevent the motors from moving the connector freely into proper position for splicing, causing motor issues. Figure 2 shows the rubber transfer tubing properly placed over the center of the clamshell. Care should also be used on the user prepared end of incoming fiber as shown in Figure 3.

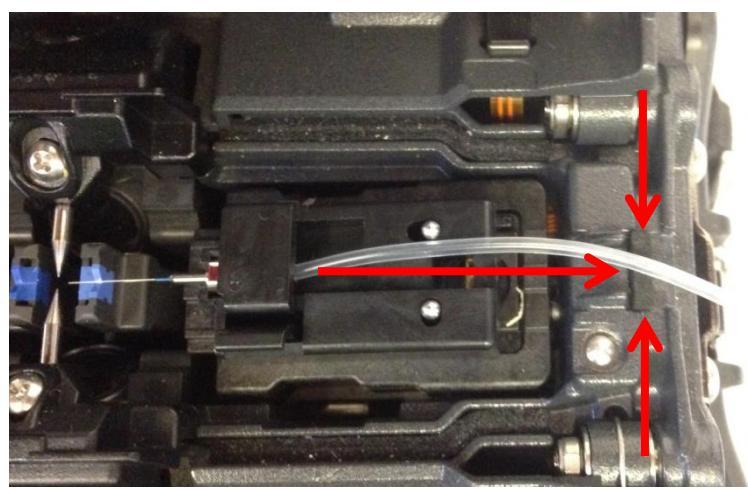
Figure 2: Correct placement of rubber transfer tubing.

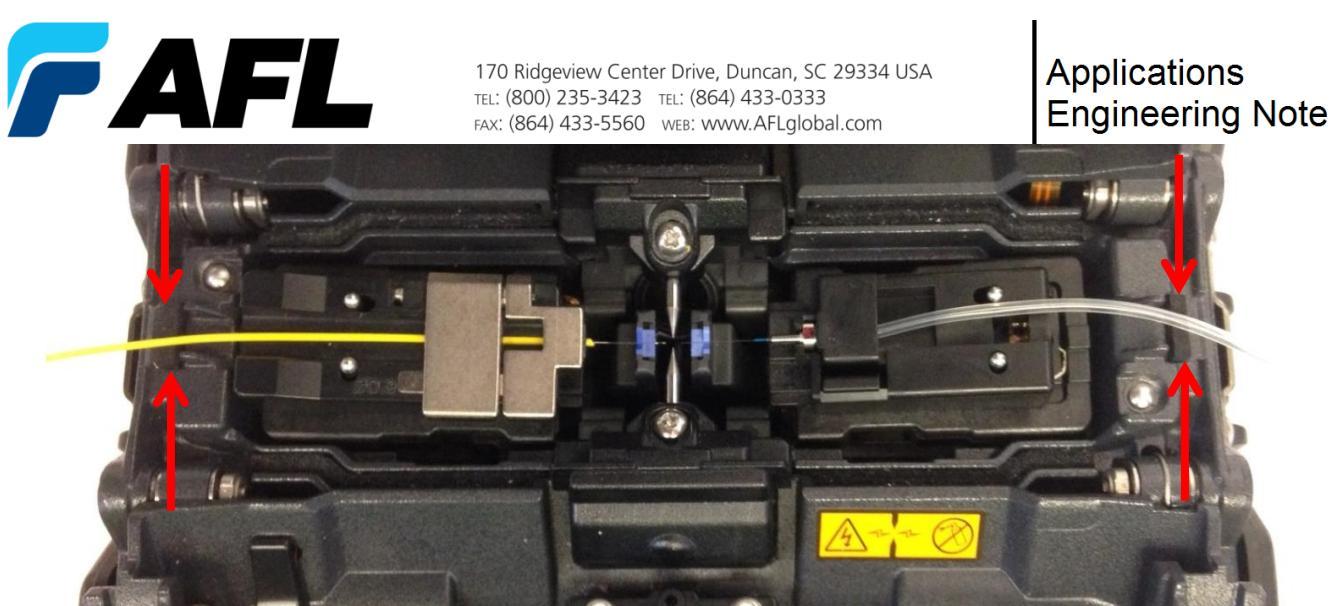
Figure 3: Correct placement of rubber transfer tubing and incoming fiber.

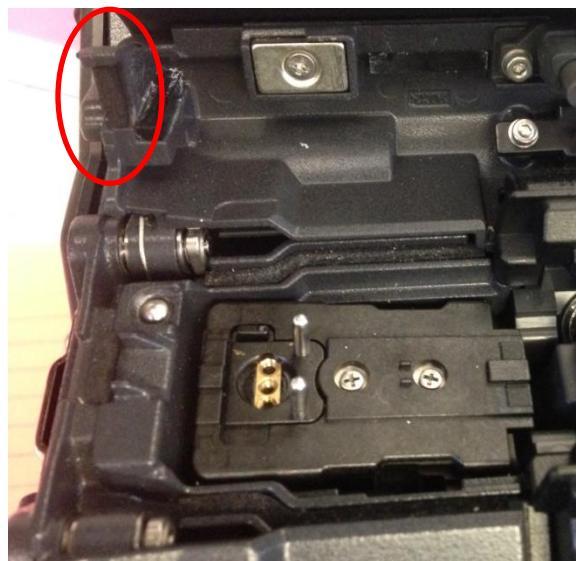
Figure 4: Left side of splicer with foam pad on clamshell lid.

METHOD B: If motor issues are still occurring after METHOD A has been observed METHOD B should be utilized. Figure 4 shows the left side of the splicer, indicating the foam pad on clamshell. In Figure 5 this pad has been removed on the right side of the splicer, the side of the splicer that the FuseConnect pre-polished end is to be placed. Removing this pad prevents the rubber transfer tubing from getting caught in the cover. This pad can be removed simply by pulling it off of the clam shell. Removing this pad will not affect normal fiber to fiber splicing splicing or the integrity of your machine.

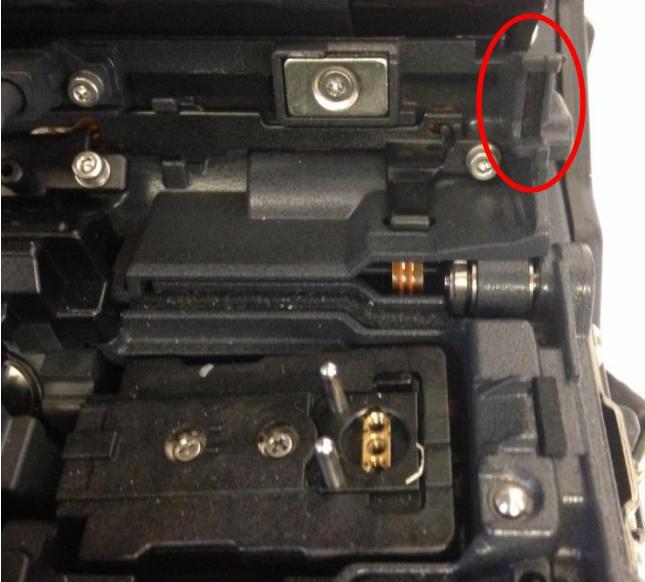
Figure 5: Right side of splicer with foam pad removed from clamshell lid.
